Concrete Scan Report

ID: ONT0023MAD20161017
17 Oct 2016

Client PO#	44456	Instrument #1	MALA CX GPR / 1.6GHz-EM
Client Reference	Roof top antennae mounting	Instrument #2	RD8000 Wand
Targets	<input checked="" type="checkbox"/> PT <input checked="" type="checkbox"/> POWER <input type="checkbox"/> STEEL <input type="checkbox"/> CONDUIT <input type="checkbox"/> STRUCTUAL SCAN <input type="checkbox"/> VOIDING		
Site Markings	<input checked="" type="checkbox"/> CRAYON <input type="checkbox"/> SPRAY MARKS <input type="checkbox"/> TAPE <input type="checkbox"/> TARGET STICKER <input type="checkbox"/> OTHER

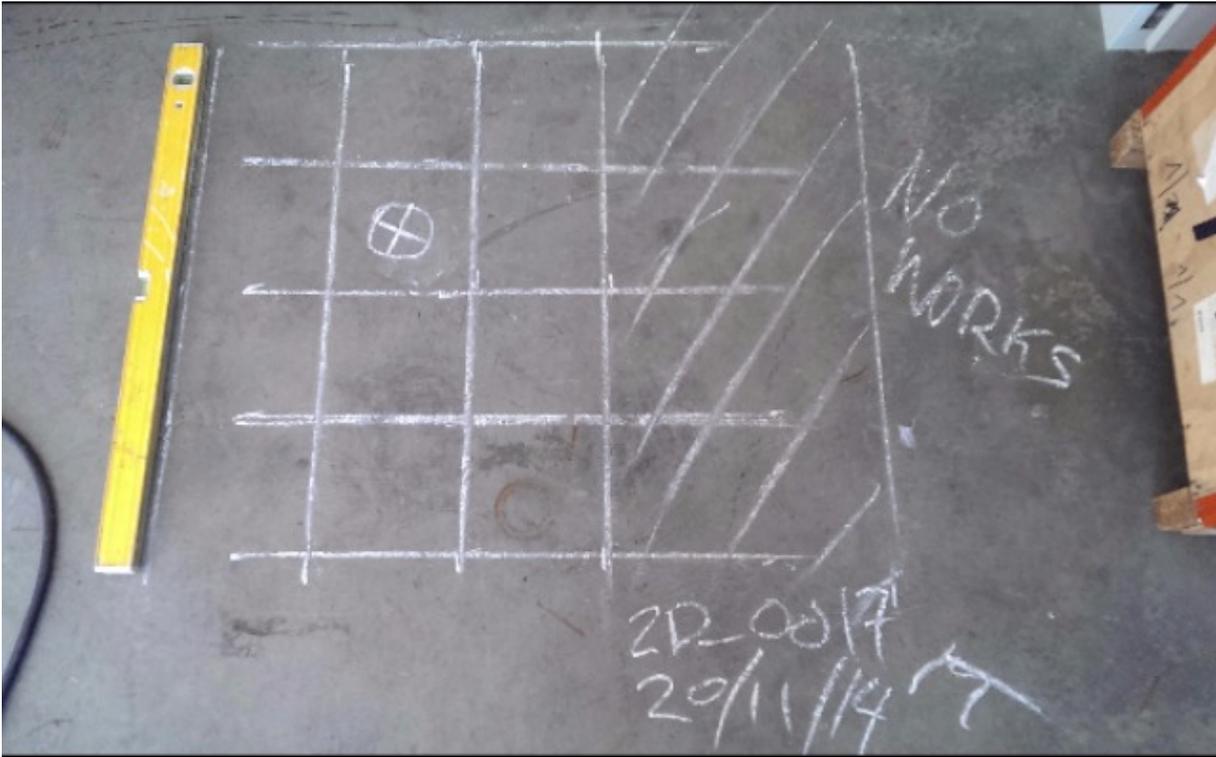
Site picture without overlay markings

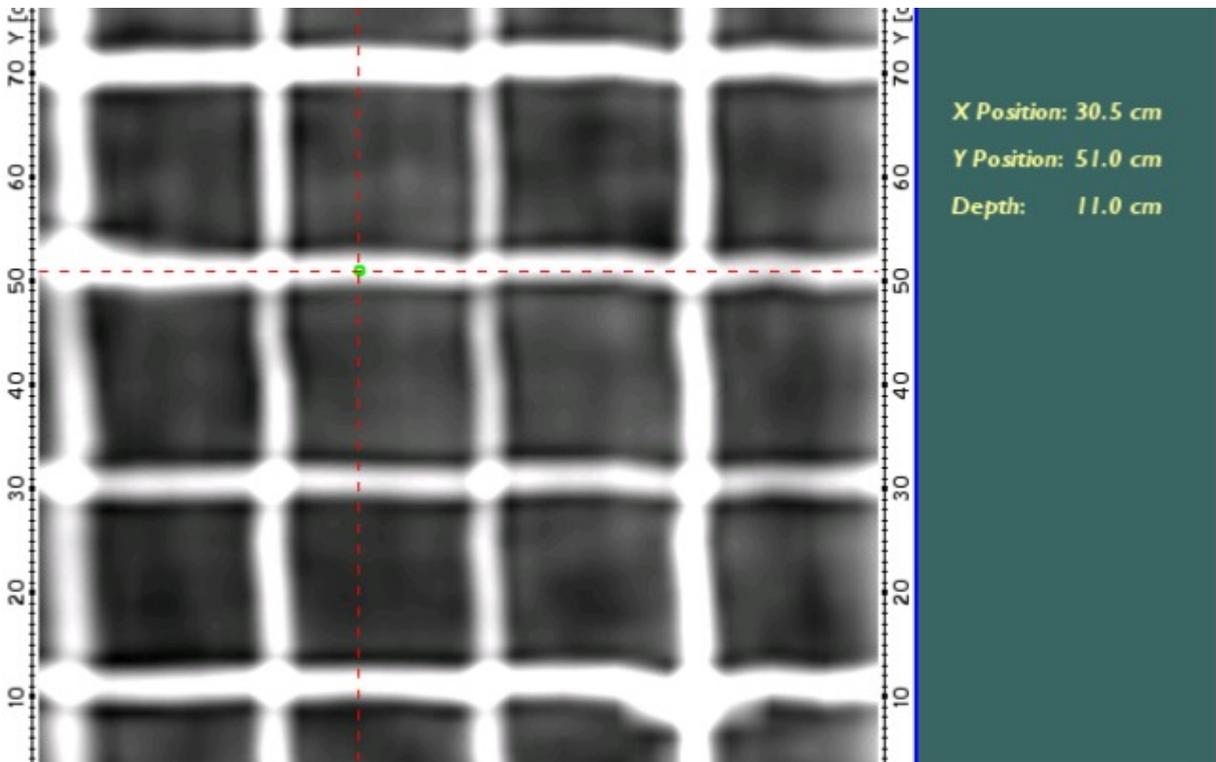
Top steel at 110mm below the surface

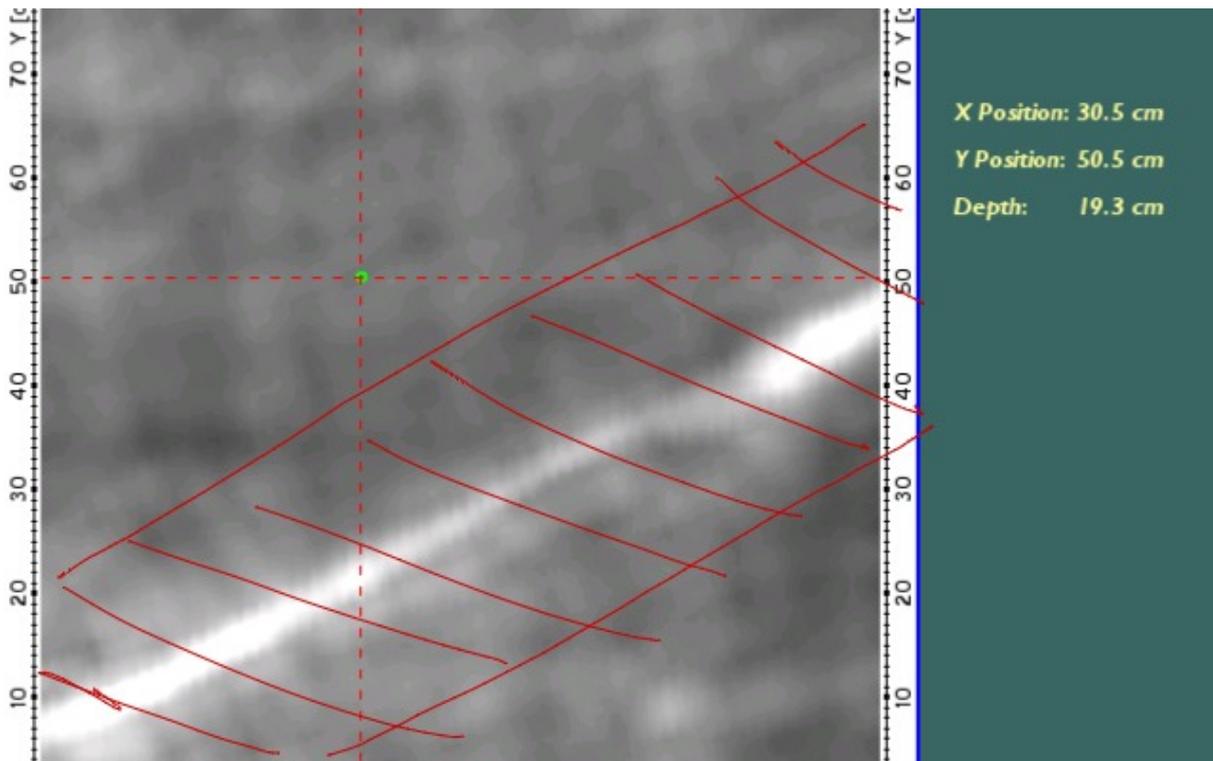
Power cable running on a diagonal at 193mm depth

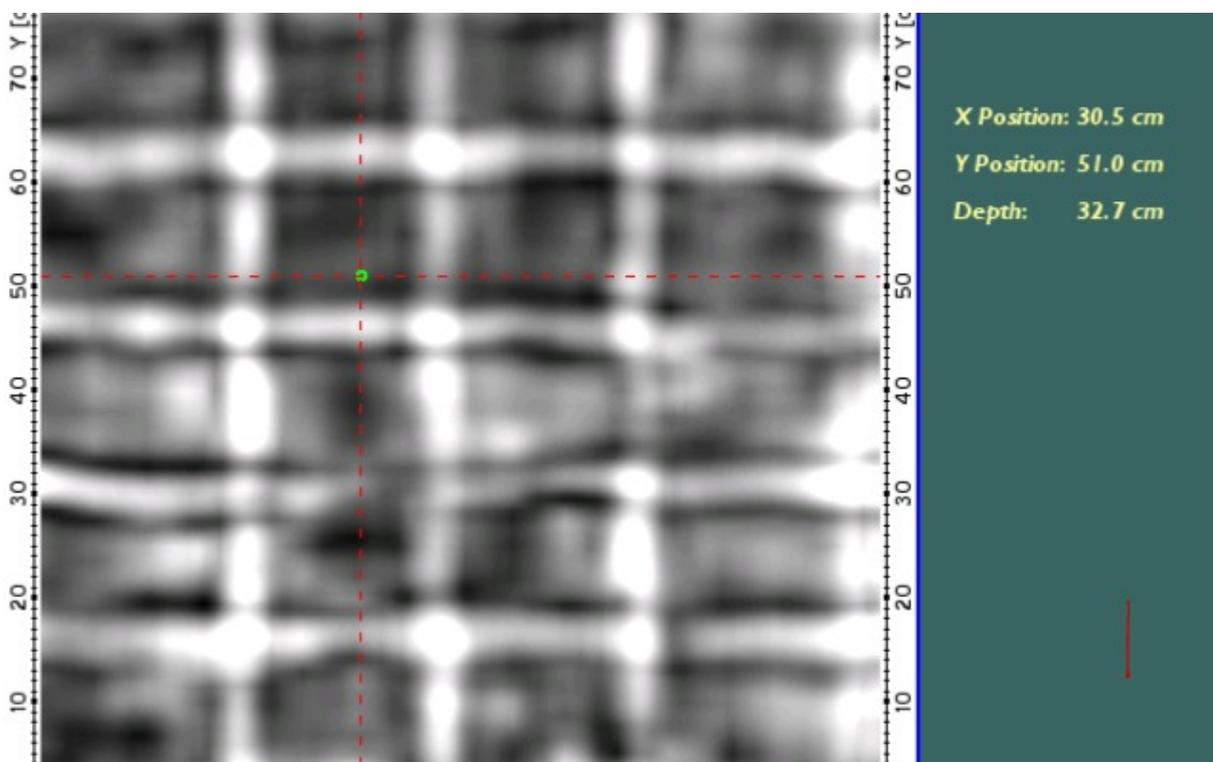
Bottom steel at 327mm below the surface.
